Inspection Report
Minerals Regulatory Program
Report Date: April 1, 2005

Mine Name: Lisbon Valley

Operator or Permittee Name:
SUMMO USA

Permit number: M/037/088

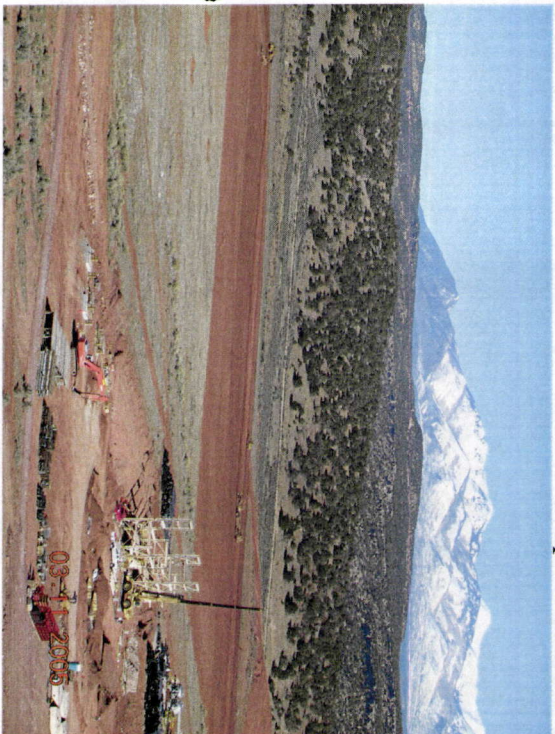
As can be seen in the attached photographs, construction continues to progress on the facilities. Some of the basic grading has been completed for the ponds, and the operator has started work on the first leach pad.

Photo 1. The area being prepared for the leach pad.

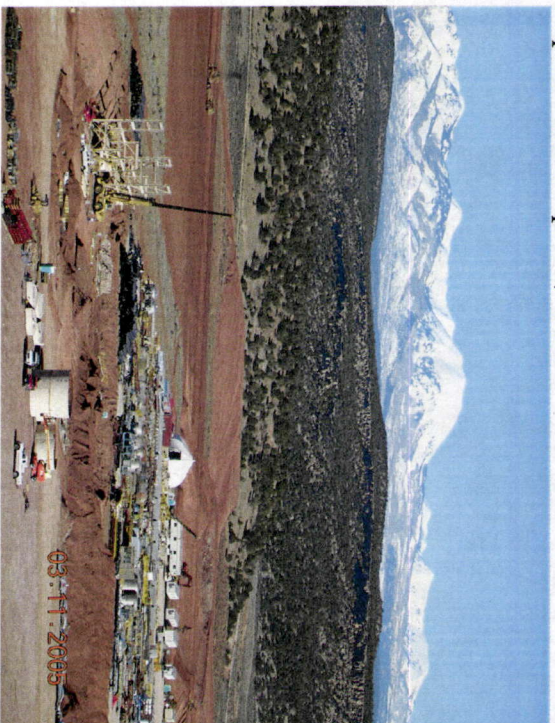
The operator has been salvaging soils from the disturbed areas. Although it appears this is being done according to the plan, I have a concern about putting these soils on 2h:1v or 3h:1v slopes on the heap leach piles during reclamation. The soils appear to be fairly erosive and are from a relatively flat area. Placing them on a slope will likely lead to erosion problems. I suggest that the operator consider either using a substitute soil material (at least for the surface) or that he consider some kind of surface armoring on the slopes.

Photo 3. Near the center of this photo (the background of the disturbances) is another topsoil stockpile.

Although spring is not the best time to seed, the soil stockpiles should be seeded as soon as possible, and I mentioned this to Mr. Indergard. I suggest seeding with an annual grain, such as winter barley, then seeding again in the fall with a semi-permanent seed mix.

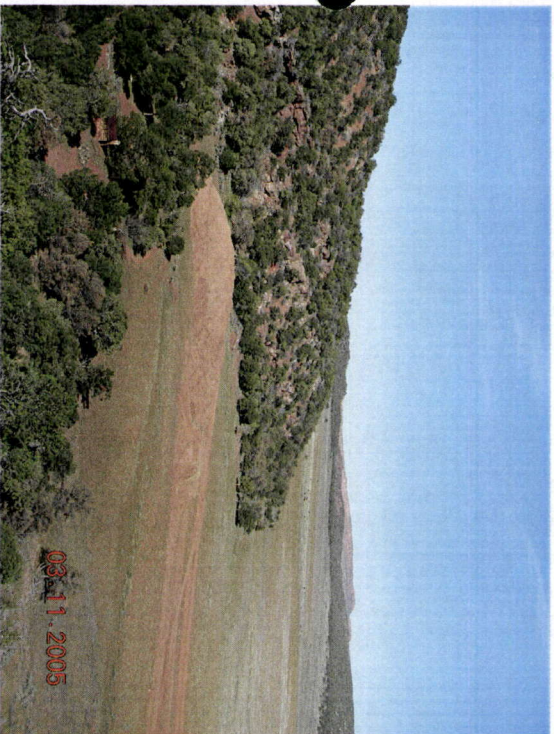
Photo 2. A topsoil stockpile to the southwest of the main disturbance area.

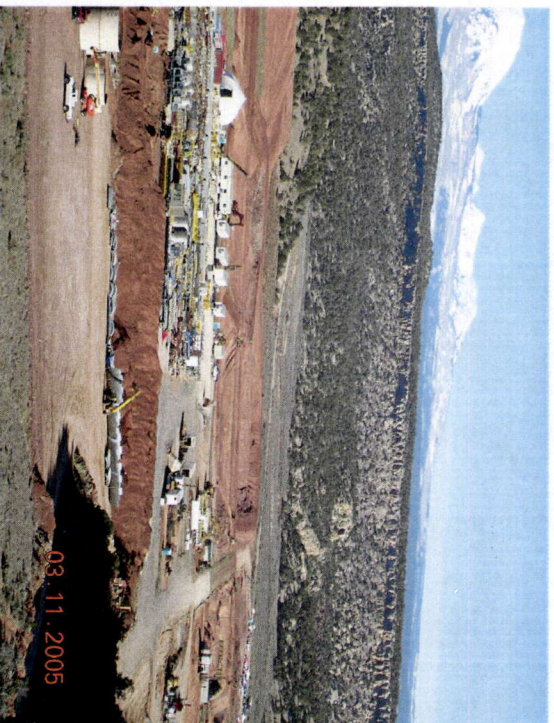
Photo 4. Near the center of this photo, one can see the area where the stormwater, raffinate, pregnant solution, and emergency ponds are being built.

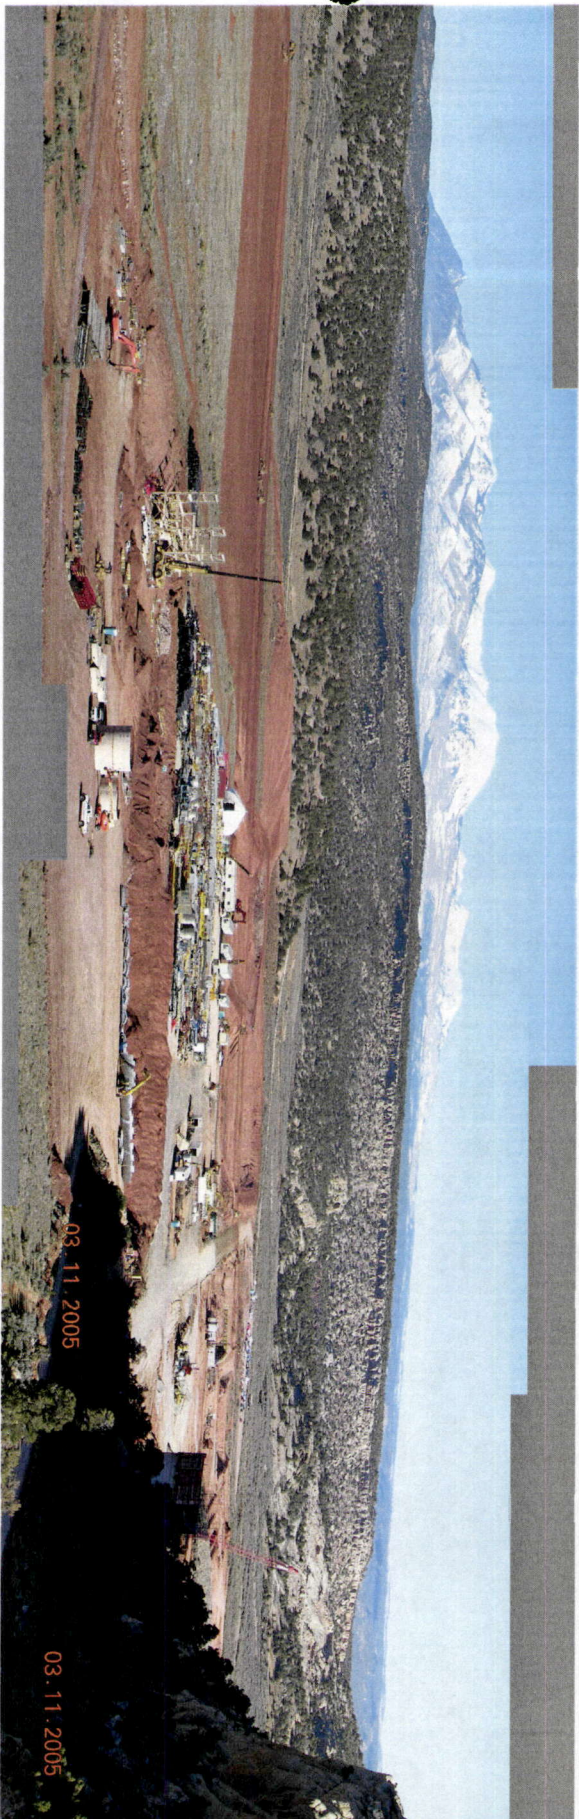
Photo 5. A panorama of the facilities area. This panorama includes three of the photos on the previous page. The primary crusher is partially in the shadow toward the lower right.
